## **Minerals Inspection Report**

| Rep | ort Date: 04/06/201 | 5 | | , |
|--|---|---|---|---|
| Mine Name: Champlin #1 | Permit Number: | S/023/0104 | Mine Status: | Suspended |
| Operator Name: Nephi Sandstone Corporation | Inspection Date: | 04/03/2015 | Permit Fees: | Delinquent |

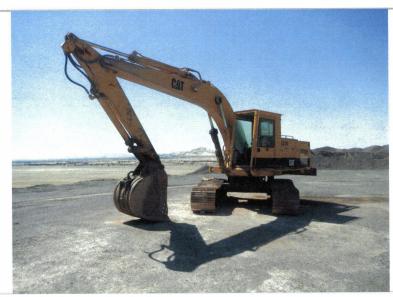
| | | 1 | |
|---|---|---|---|
| | There is an excavator on site that has been there for several years. There is the potential for | fluid leaks. | |

Excavator that has been on the site for years.

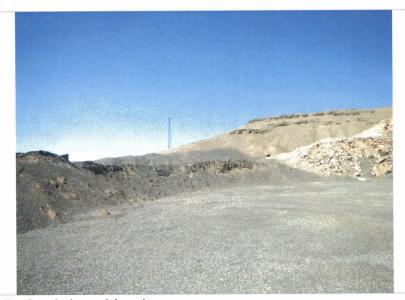
Stockpile of crushed material on site.

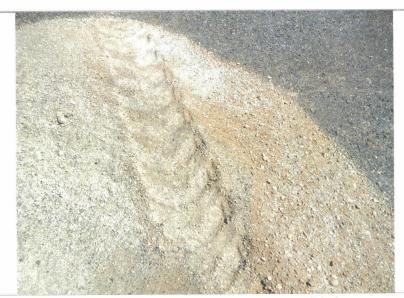
Tire tracks for a large vehicle were on site. The Division cannot tell is there were unauthorized mining activities being conducted.

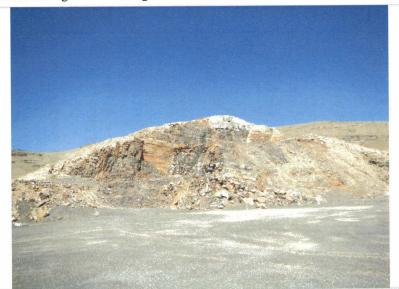
| | | 1 | |
|---|---|---|---|
| | There are highwalls on the site that are stepper than 45 degrees. | | |

Steep un-reclaimed highwalls.
